**DYNAMIC SCIENCE, INC.**  
In-Depth Accident Investigation

Contract DTNH22-94-D-27058  
Case DSI-95-AB-23

1. Report No. DSI-95-AB-23		2. Government Accession No.		3. Recipient Catalog No.	
4. Title and Subtitle  In-Depth Accident Investigation Washington				5. Report Date 1996

14. Sponsoring Agency Code	
15. Supplemental Notes  Driver of 1989 Dodge Daytona killed during airbag deployment.					
16. Abstract  This case was initiated because the driver died as a result of her interaction with a deploying airbag. This fatal collision occurred in 1995 at hours in the state of . Vehicle 1, a 1989 Dodge Daytona driven by a 17 year old female, was stopped at a stop sign at a four-leg intersection facing north. Vehicle 2, a 1991 Pontiac 6000 LE driven by a female, was also stopped at this intersection facing in the opposite direction. The driver of Vehicle 2 entered the intersection, with the intention of going straight, and into the path of Vehicle 1 which was turning left. The left front of Vehicle 1 struck the left side of Vehicle 2. The driver's side airbag deployed at impact. The unrestrained driver of Vehicle 1 was pitched forward slightly and the deploying airbag caught her in th

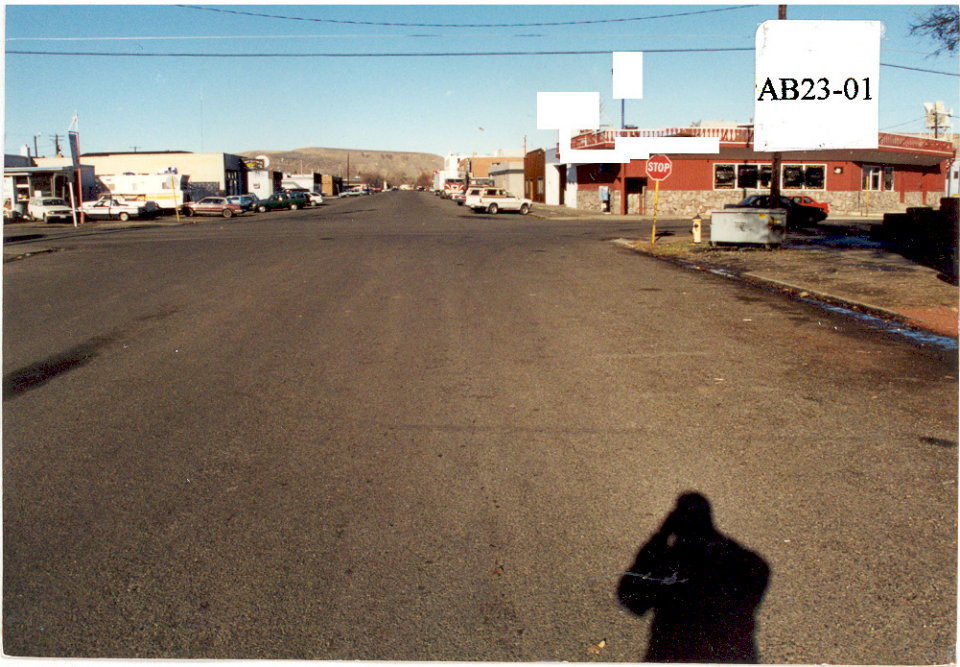
AB23-01

PHOTO NO.	VEHICLE NO.	DIRECTION OF PICTURE	SUBJECT MATTER
1-2	1	North	Path to area of impact.
3	1	NW	Area of impact.
4-5	2	South	Path to area of impact.
6	2	South	Area of impact.
7-17	1	CCW	Vehicle exterior.
18-43	1	NA	Vehicle interior.
